DOWNTOWN DESIGN GUIDELINES CITY OF NOBLESVILLE

Noblesville, Indiana
February 2008

DOWNTOWN DESIGN GUIDELINES

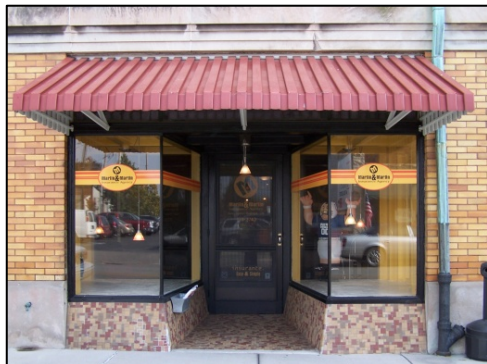
This early twentieth-century storefront maintains its recessed entry, large display windows, and unusual mosaic bulkheads.

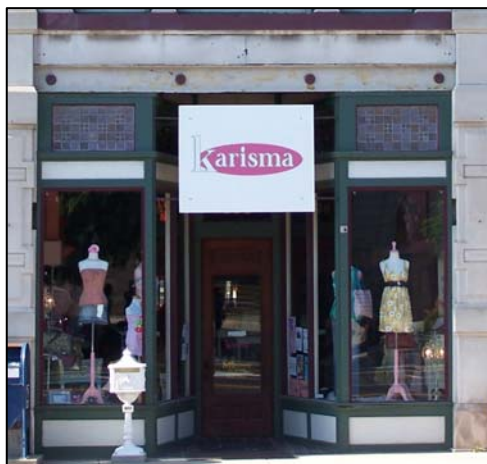
This storefront has retained its original display windows, bulkheads, transoms and recessed entry. The storefront space allows the store owner to advertise the goods sold within.

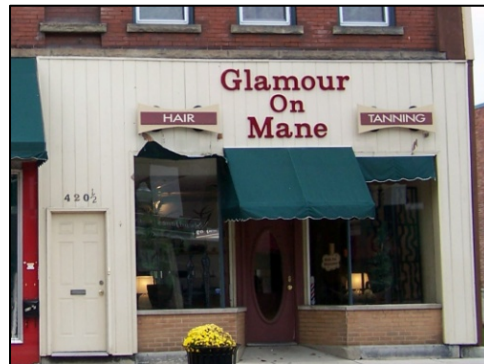
This storefront and storefront cornice have been encased in wood veneer and the bulkheads replaced with modern masonry.

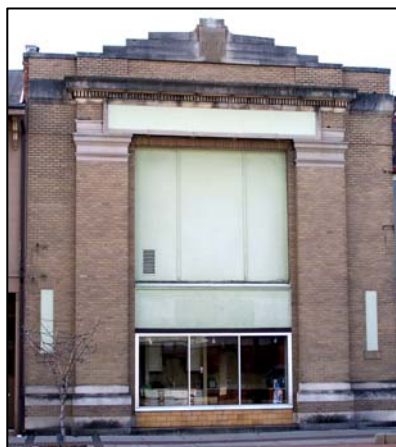
Covering up doorways and large sections of glass on a historic storefront detracts from the appearance of the building and is discouraged.

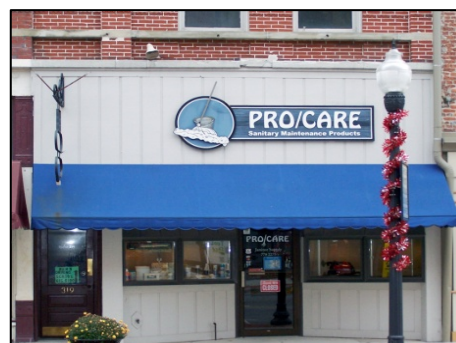
This storefront has altered the size of its display windows and encased the storefront and storefront cornice in wood veneer.

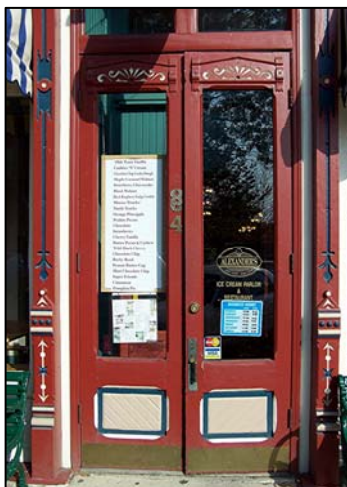
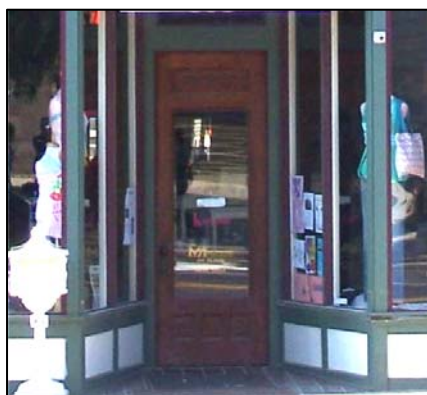
Pairs of tall, narrow wooden doors lit by large panes of glass were commonly found on historic storefronts from the nineteenth century.

This doorway retains its historic wood and glass door with kickplate and a transom above.

This type of wood, lit by a single pane of glass and having a brass kickplate, was commonly used on historic storefronts.

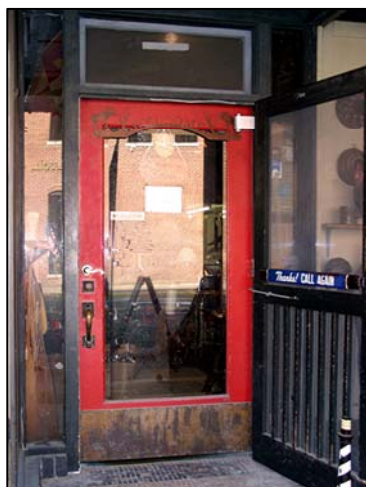
This modern residential replacement door has features that are inappropriate for a storefront. The transom has also been covered.

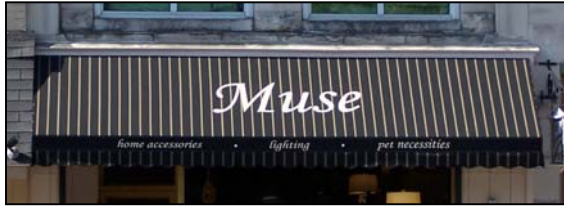
Canvas awnings appropriately scaled to the storefront and that do not obscure the signboard or other decorative elements are recommended.

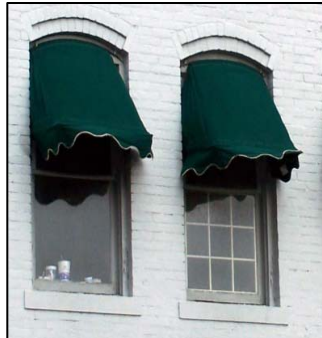
These canvas awnings, installed on upper story windows, are appropriately sized and do not obscure the brick window moldings.

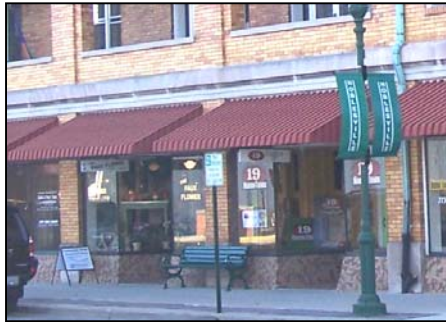
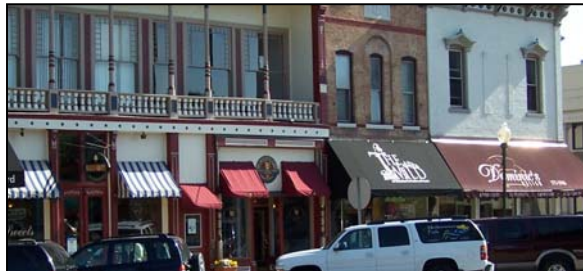
These historic awnings are important design features of the building and should be retained.

These awnings divide the storefronts and add personality and color to the historic building facades.

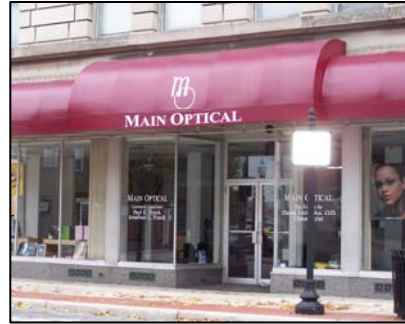
Molded plastic awnings that obscure the storefront cornice and signboard are discouraged.

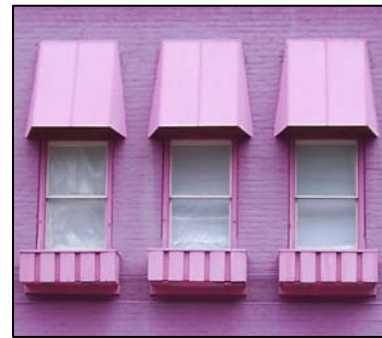
These metal awnings, installed on upper story windows, extend outside of the masonry openings and obscure decorative details.

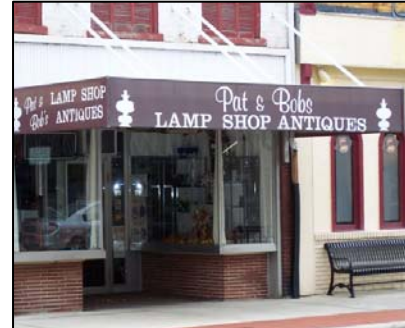
Replacement metal awnings are not recommended, especially when they cover the storefront signboard or cornice.

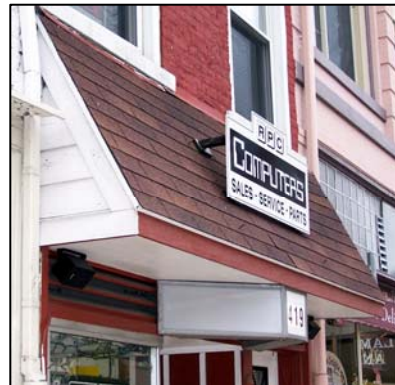
This fixed wood awning is a late twentieth-century addition and is not recommended.

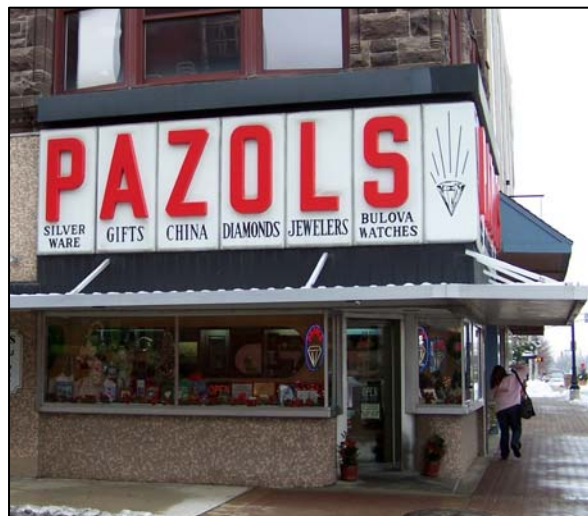
This large internally-lit plastic sign overwhelms the storefront and is not compatible with the style of the historic masonry building.

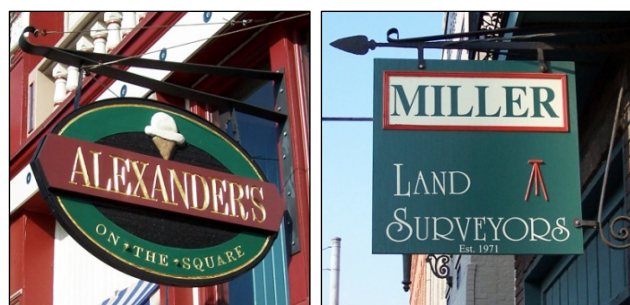
These new projecting signs are composed of traditional materials, are pedestrian scaled, and are designed to be compatible with the building.

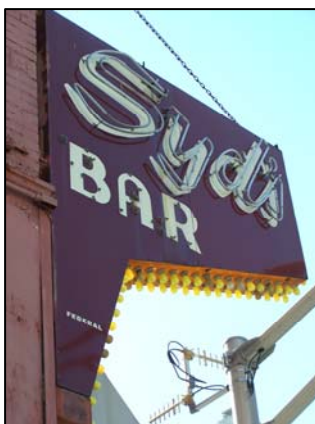
Mid-twentieth century neon signs have often acquired significance in their own right and should be preserved.

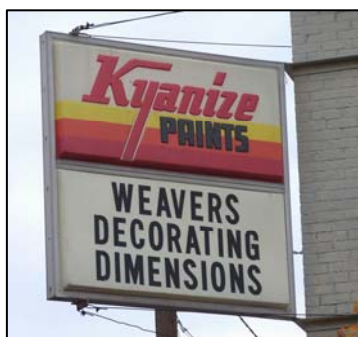
Internally-lit plastic signs, similar to the example above, are discouraged.

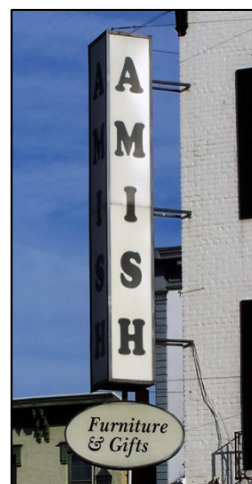
Large internally-lit plastic projecting signs that are out of scale with the building are discouraged.

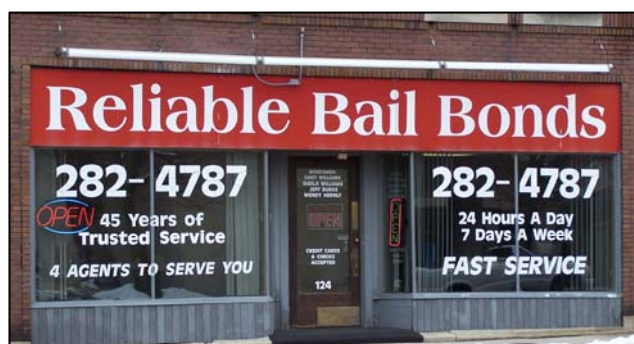
In this example, the signage is out of scale with the rest of the storefront. A large sign obscures the storefront cornice, and the painted window signage overpowers the display windows.

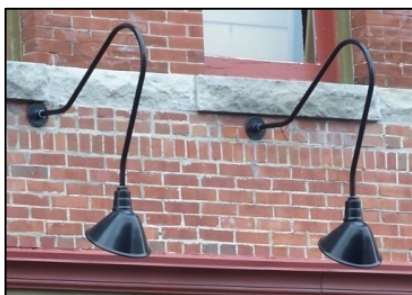
New lighting that is simple and unobtrusive in design can be effectively used to light a storefront.

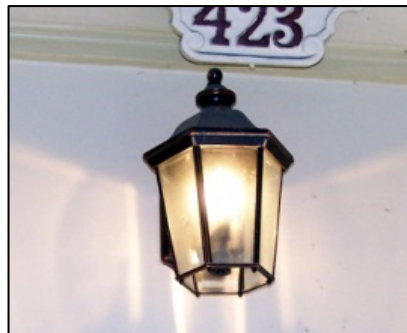
The use of light fixtures intended for residential buildings is discouraged on commercial buildings.

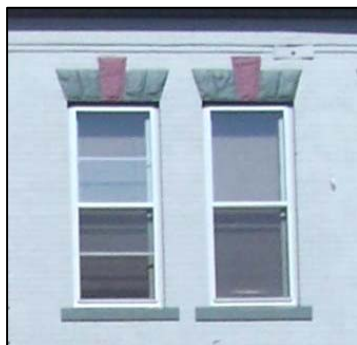
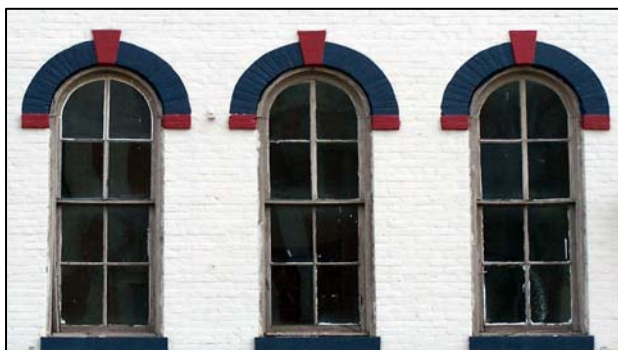
These double-hung replacement windows mimic the appearance of historic windows in size, shape and material.

These historic windows retain their original arched sash and divided lights (panes).

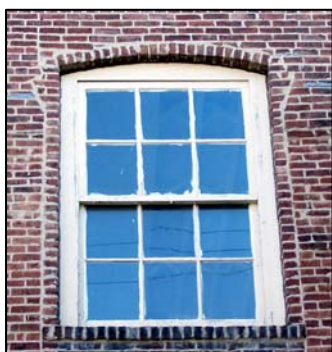
This window on a rear elevation has been preserved and maintained.

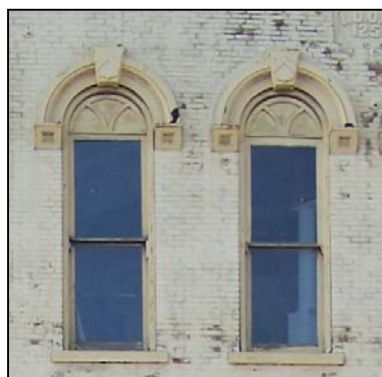
These double-hung windows maintain their original ornate details that add character to the building's historic façade.

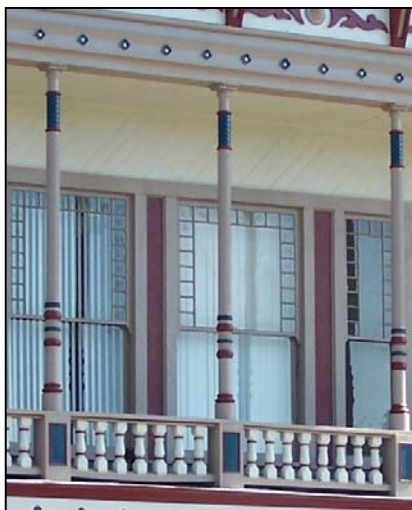
This ornate balcony provides visual interest to this historic building façade and should be repaired and preserved.

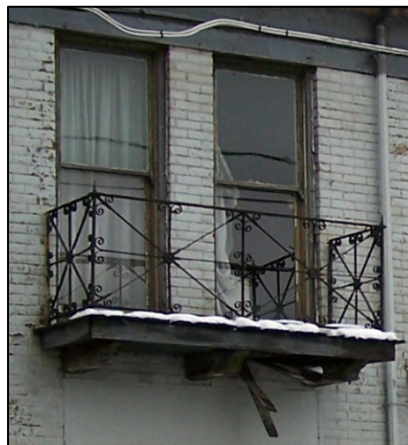
This balcony is in desperate need of repair and has the potential to cause injury. Every effort should be made to preserve the character-defining feature of this façade.

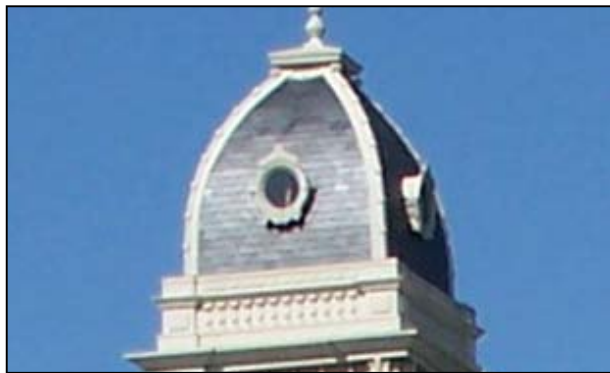
Historic roofing materials, such as patterned slate, and the distinctive shape of this mansard roof are important design elements and should be retained and repaired whenever possible.

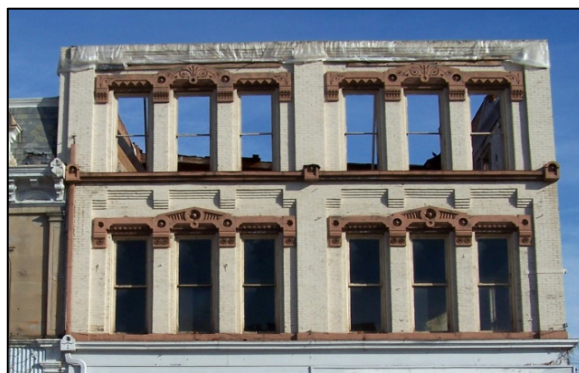
Neglecting the roof of a historic building can have disastrous results, as in this example where the roof has completely collapsed. Regular maintenance and repair of any roof is an essential step in protecting a building.

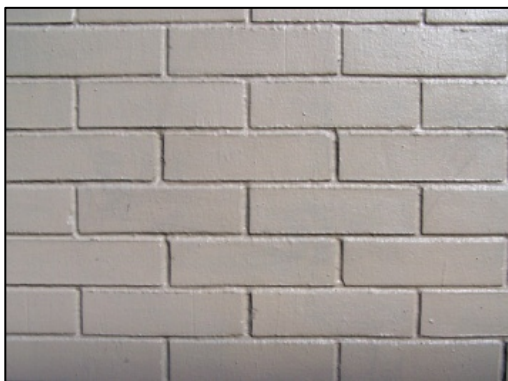
Painted brick in good condition should not be stripped, which has the potential to damage the wall surface.

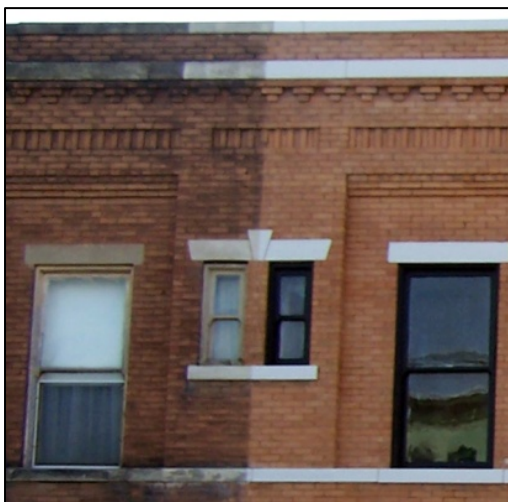
Cleaning brick or other masonry is recommended using the gentlest means possible.

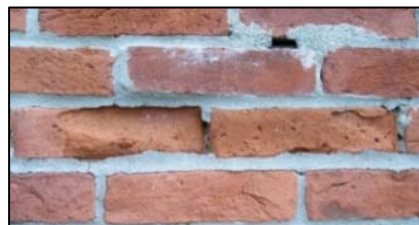
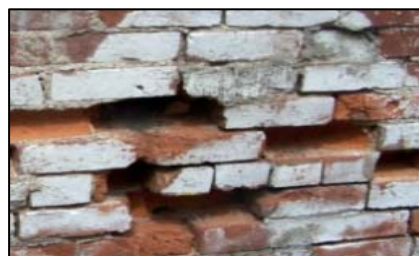
Sandblasting of brick or other masonry materials will damage the surface and expose softer brick that is highly susceptible to water damage.

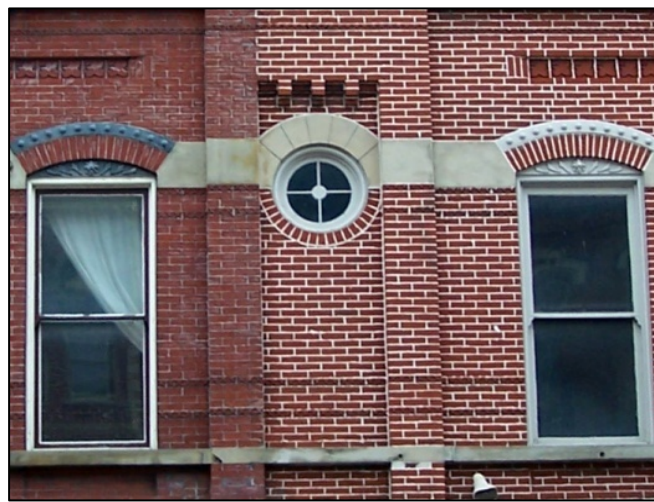
The brick on the right has been repointed with a mortar that does not match the existing mortar. The joints have been excessively widened in the process.

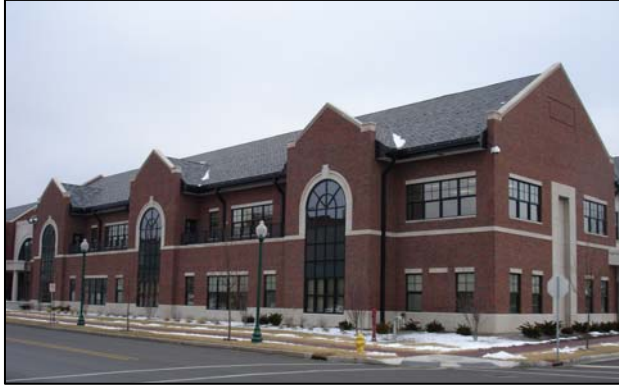
This addition is an example of new construction that is compatible with the adjacent historic building in both height and setback, and displays decorative features and window openings that reflect the historic character of the downtown.

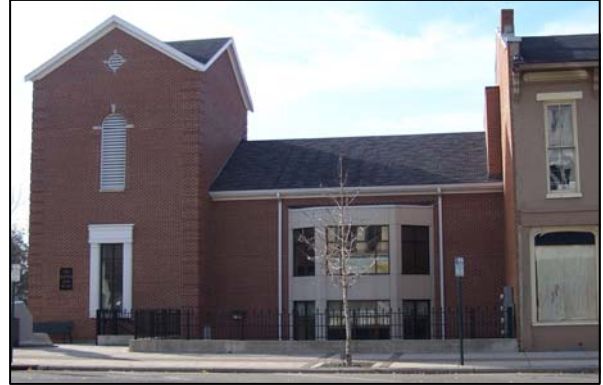
This example of new construction in a historic downtown is incompatible with adjacent buildings in both height and setback.
